INDOOR AIR QUALITY ASSESSMENT

**Executive Office of Elder Affairs
One Ashburton Place, 5th floor
Boston, MA**

Prepared by:
Massachusetts Department of Public Health
Bureau of Environmental Health
Indoor Air Quality Program
November 2017

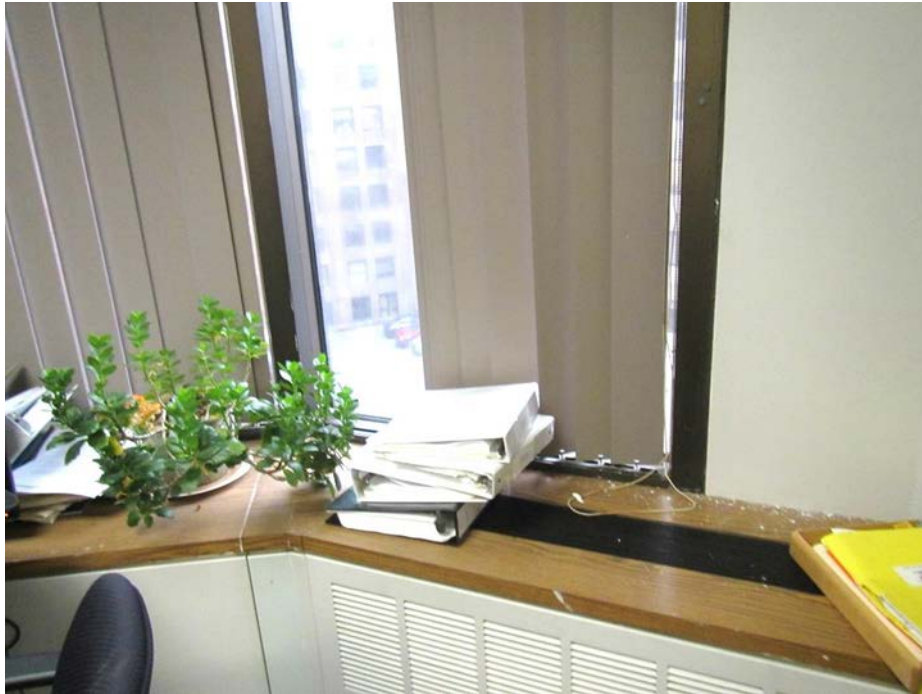
Picture 1

Fresh air is supplied by induction units located along the outer edges of the building (Picture 1). Return air is drawn through grates or around light fixtures using ducted returns. As shown in Picture 1, some induction units had items on top of them, which can obstruct the flow of fresh air. In addition, some of the items on/near the vents of the induction units can be a source of dusts, odors and, in the case of plants, pollen and other potential allergens. Induction unit vents should be kept free of items and kept clean.

Plants were also noted in office 5030 (Picture 1). Plants can be a source of mold, pollen and other allergens and should be well-maintained and not placed on porous materials or in the airstream of ventilation equipment.

Induction unit with items and plants on top

Ventilation equipment should be kept free of items to prevent restriction of airflow. Induction units need to be cleaned periodically to remove dust and debris that can be a source of irritation when ventilation is operating.

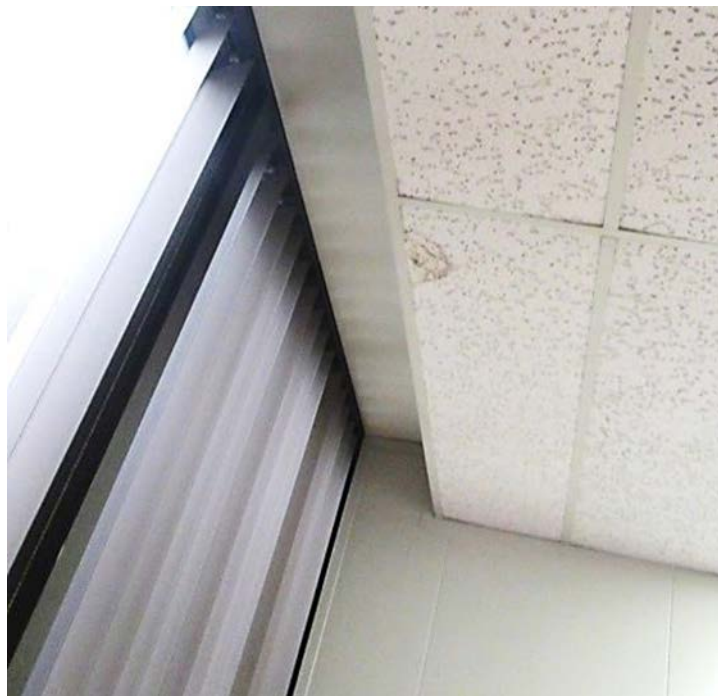
Picture 2

Signs of water infiltration were noted in office 5030 including water-damaged ceiling tiles (Picture 2), an area of bubbling paint and efflorescence (Picture 3), and water stains on paper on the windowsill. The ceiling tile was removed and the area above it was examined. Above the ceiling tile system in this area is an open volume of space crossed by metal bracing and other materials that are not supportive of mold growth. No moldy odors or mold staining was observed on any of the materials above the ceiling tile system. Note that efflorescence like that shown in Picture 3 is the result of water moving through a material such as brick and plaster. Dissolved minerals from the material precipitate out on a surface when the water evaporates. While this is an indication that there is a periodic water leak in this area, it is not microbial growth. A water-damaged ceiling tile was also observed in adjacent room 5031. Water-damaged

tiles and other signs of water damage indicate that there are periodic leaks from the building envelope in this area.

Water-damaged ceiling tile

1. If leaks reoccur, ensure that all moistened materials are dried or removed within 24-28 hours, per EPA recommendations (US EPA, 2008; ACGIH, 1989).
2. Do not store any items on ventilation equipment or underneath areas where water has been known to leak.
3. Have induction units cleaned of dust and debris periodically.
4. Reduce use of products containing VOCs including eliminating air freshening products.
5. Clean carpeting in accordance with IICRC recommendations (IICRC, 2012).

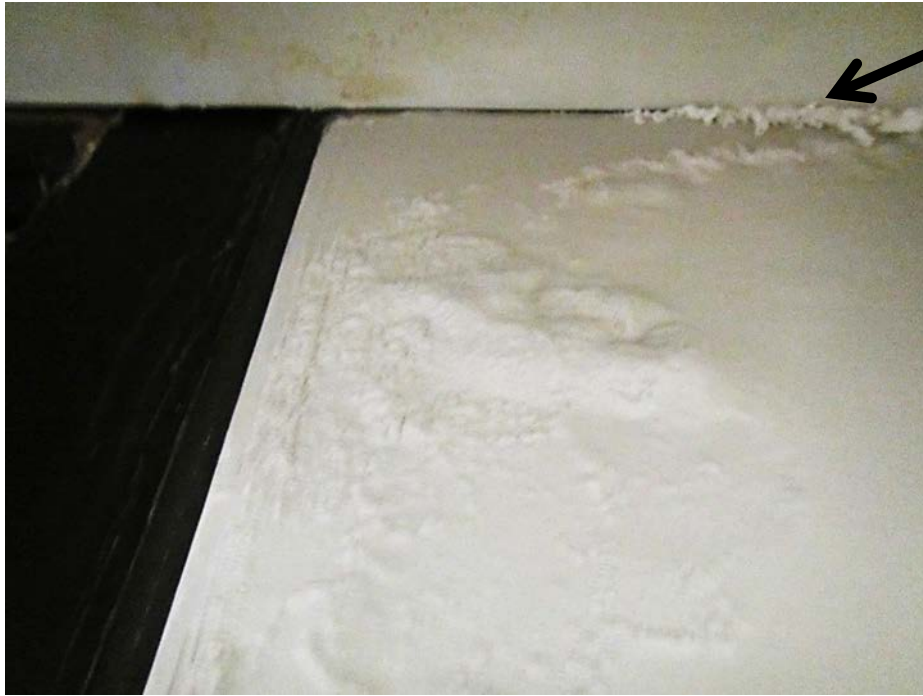
Picture 3

Bubbled paint and efflorescence (arrow)
